**CONTINUING ELIGIBILITY INSPECTION (CEI) REPORT
FOR HURRICANE & SHORE PROTECTION PROJECTS**

1. Project Name: Vatia Shore Protection Project
2. Date of Inspection: April 9, 2002
3. Inspection Personnel:

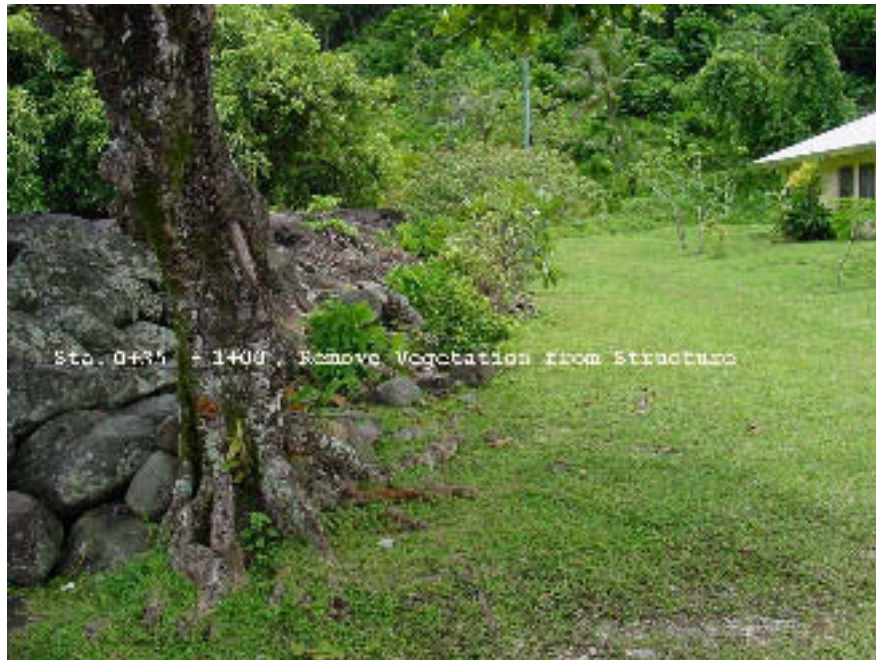
a. Sta. 0+50 Interior tieback, remove vegetation growing among interior toe stones.

The focus of the maintenance required should be directed at vegetation control. Removal or herbicides are recommended in lieu of cutting.

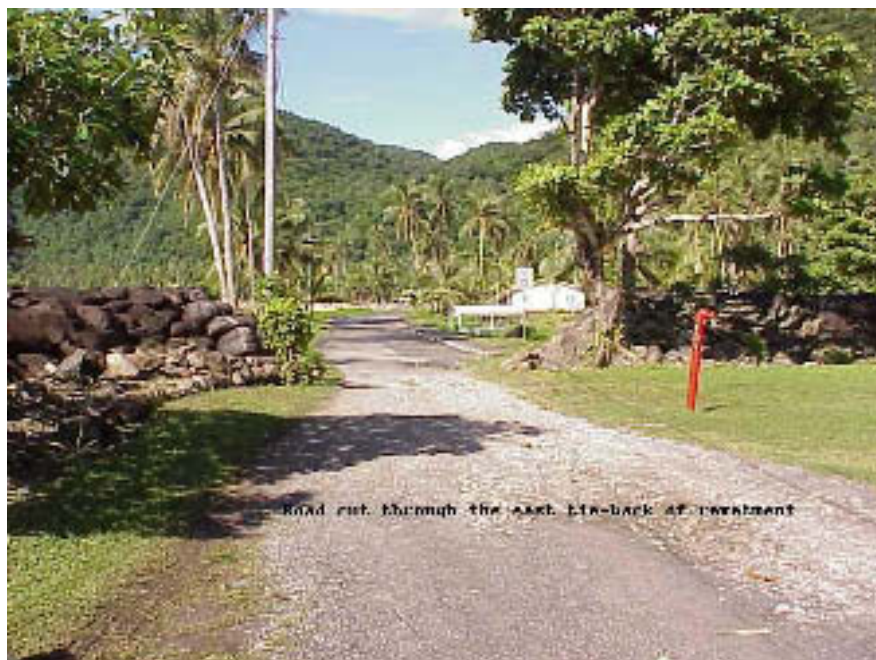
b. Sta. 2+10 a 15', The coral road through the revetment is OK.

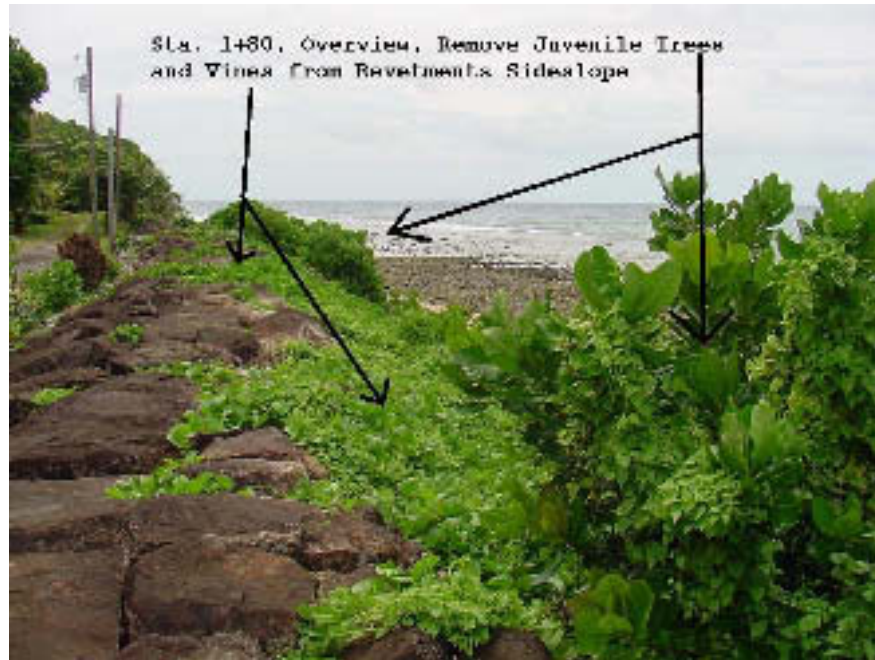
c. Sta. 1+80, Remove vegetation that covers structure.

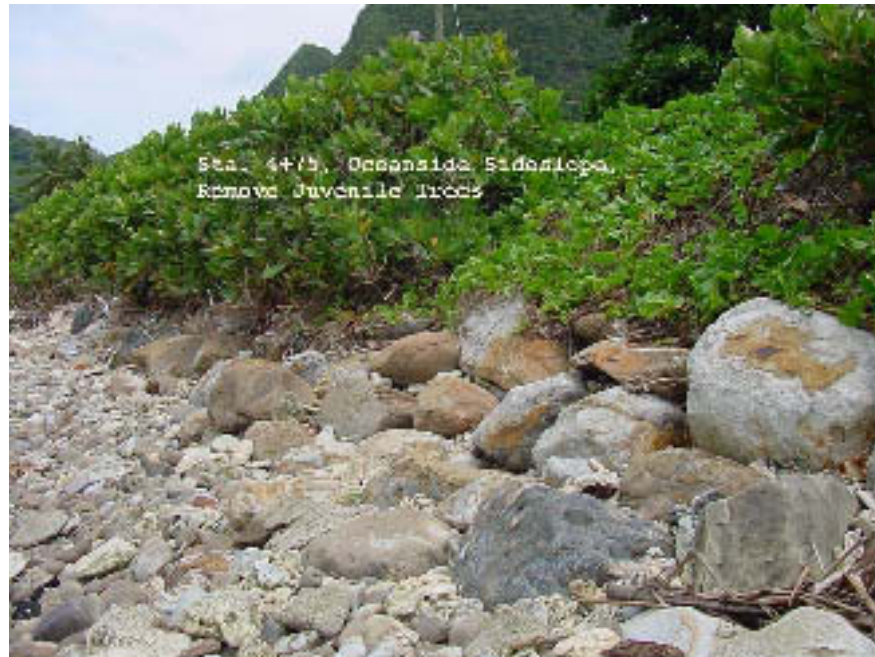
d. Sta. 2+50 to 5+00, Remove juvenile trees from the sideslope.
 Note: A coral beach is forming immediately in front of the revetment
 with a beach berm up to two feet MLLW.

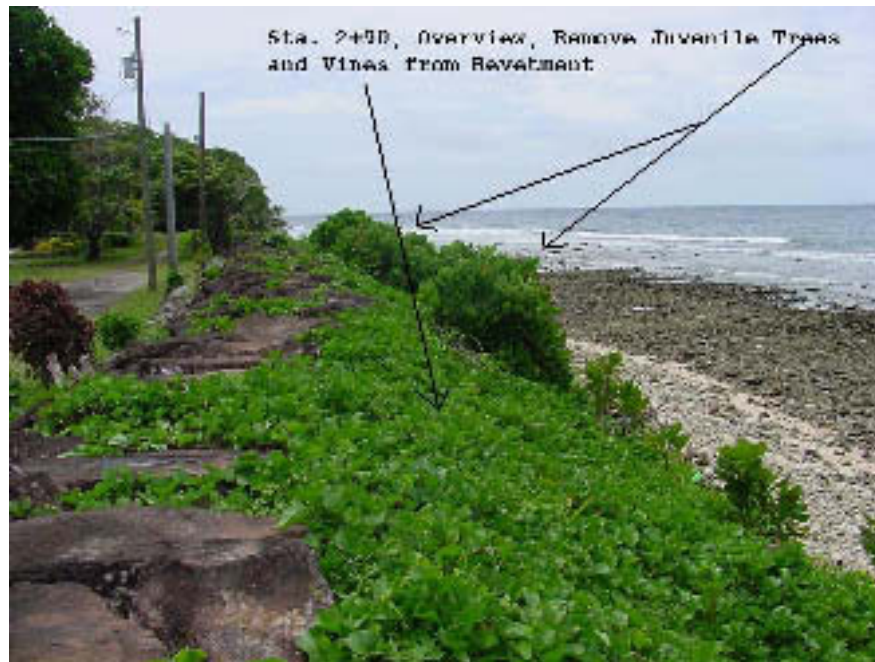
e. Sta. 2+90, Trees on sideslope need to be removed.

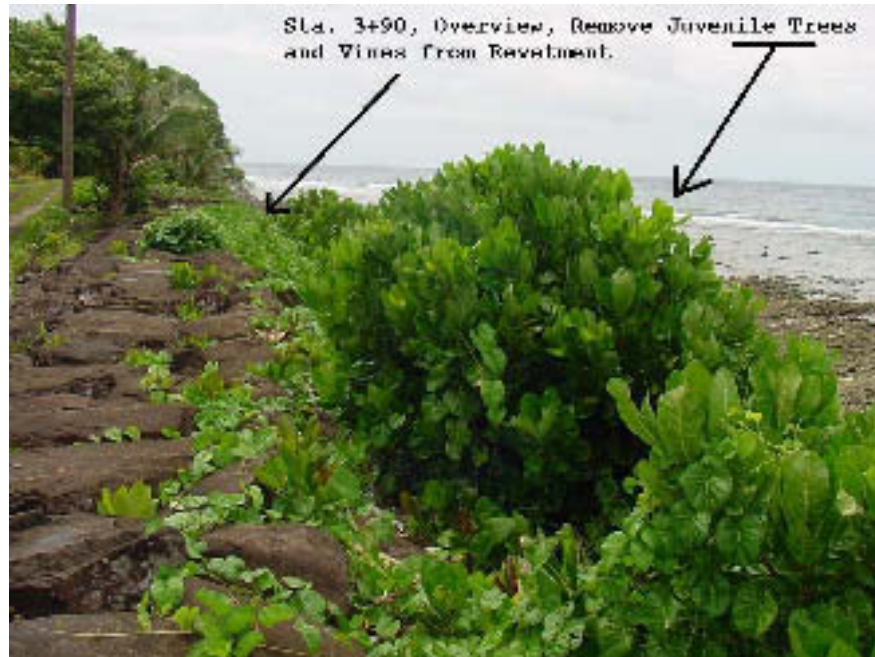
f. Sta. 3+90, Trees on sideslope need to be removed.

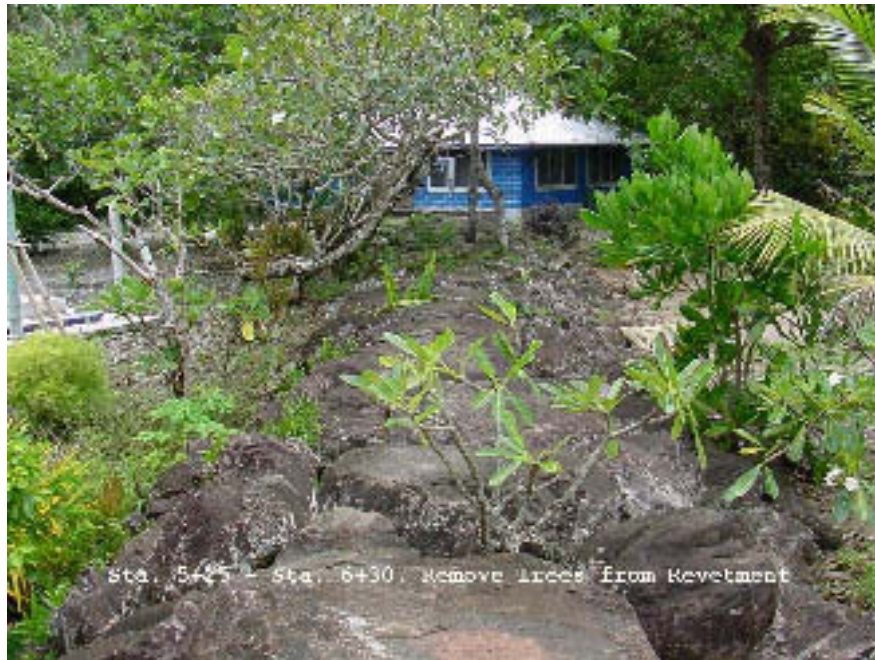
i. Sta. 5+25 - Sta. 6+30, Remove a large ulu (breadfruit) tree and other juvenile trees growing among the armor stones at the crest.
